**Original Scientific Paper**

**EVALUATION OF IMPACT OF EARTHQUAKE ON AGRICULTURE IN  
NEPAL BASED ON REMOTE SENSING**

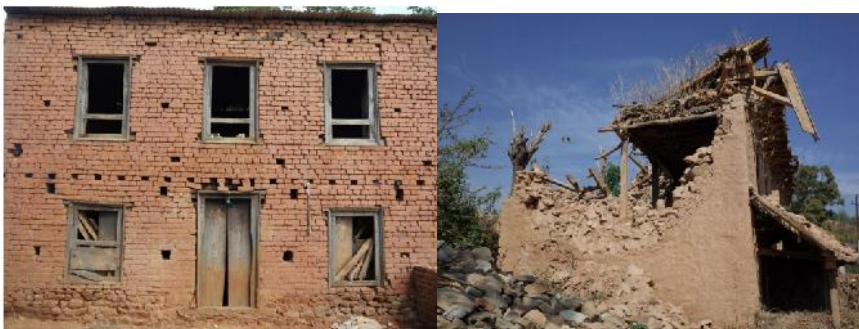
Figure 2. Difference of building damages between house materials  
Bricks and woods (left) and Muds and rocks (right)

As results of questionnaire survey, most of the farmers mentioned that soils became dry after the earthquake, although its cause could not be identified. For the loss of water source and the lack of precipitation after the earthquake, it was causing them poor harvesting and living. The houses and barns were significantly damaged in most of the villages. Besides that, the relief has been insufficient to repair them. By the time of the survey, they had made quite temporal and simple repair on their houses. Therefore, many of them sleep outside of their houses because of fear of house collapse and suffer from cold during nights. Although some houses were mainly built by bricks and woods, most of houses were built only by muds, rocks or unbaked bricks (Figure 2). Thus, the building damages were more significant in houses built only by muds, rocks or unbaked bricks.

For this reason, the loss of livestock was also significant because of the collapse of barns. Severe damage on agricultural facilities such as canals was not observed. Totally 136 houses were investigated and the damage scale among partial, half and total collapse was 21.3%, 12.5% and 65.4%, respectively. Thus, most of houses were totally collapsed (Figure 3). The valuable data such as the results of the questionnaire survey and location information of damaged buildings was obtained through visiting villages one by one.

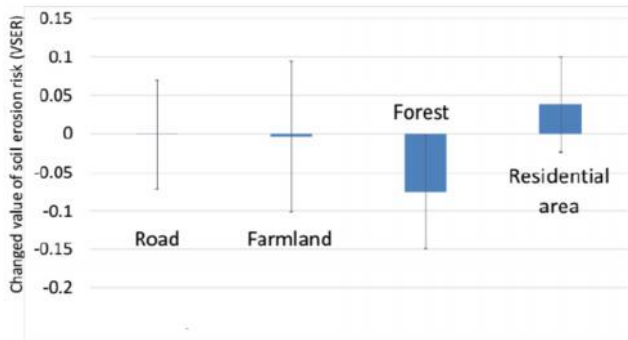
Figure 6 Changed value of soil erosion risk (error bar shows standard deviation)

From this, it was observed that the soil erosion risk was not changed in agricultural land averagely, but decreased in forest area and increased in residential area (Figure 6). Therefore, vegetation cover needs to be increased to avoid further erosion phenomena after the earthquake, and land reclamation is not encouraged for dwelling or agriculture from forests. Although soil erosion risk would be influenced by land slope degree, the correlation coefficient was low ( $R=0.08$ ) between the risk and the slope degree generated from ASTER GDEM. As ASTER GDEM's spatial resolution is 30m, there might be the map was not sufficiently replicate the undulating and steep slopes in the research area. Therefore, there is a need to apply a DEM (digital elevation model) with higher resolution for the more accurate study.
